BULLETIN

News from *SubTerra, Inc.*[®]

Blast Monitoring near the Falls Terrace Restaurant Tumwater, Washington

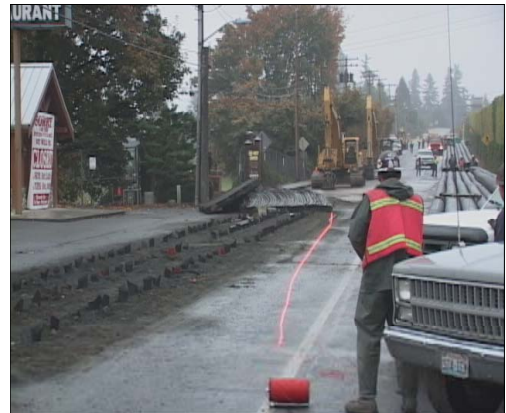
Monitoring results were reviewed following each blast, and used to provide immediate input to subsequent blast designs. The recorded blast vibration levels were generally below recognized “safe limit” criteria. However, monitors installed in pavement between 6 to 8 ft. in front of the

restaurant recorded vibrations in excess of these “safe limit” criteria for several blasts. This was most likely the result of a localized amplification of energy in the asphalt.

Since the pavement was not directly connected to the restaurant foundation, it was unlikely these higher vibrations would be transmitted to the restaurant structure. This proved to be the case, as observed during the post-blast inspection, in which no blast-related damage was found.
