News from **SubTerra, Inc.**<sup>®</sup>

## **US Army Corps of Engineers Cougar Dam Downstream Diversion Tunnel Baseline Condition Survey, Blue River, Oregon**

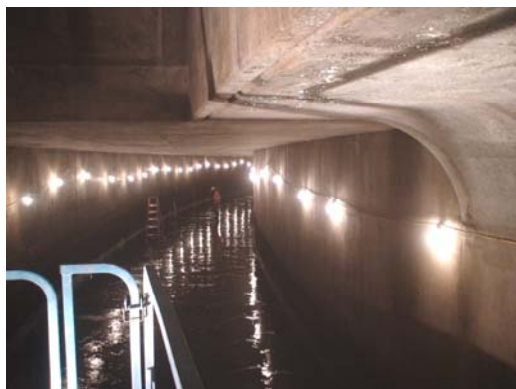
**Left:** Diversion Tunnel at the cross section change looking downstream. **Above:** The upper unlined tunnel looking upstream toward the Gate Chamber Access Walkway.
