BULLETIN

News from SubTerra, Inc.®

Underground Sports Court Water Proofing Evaluation Lake Oswego, Oregon

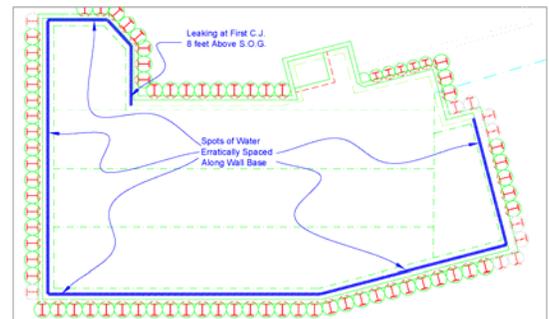
Structurally, the design relied on tangent piles supported by cross-beams during construction then braced by ceiling beams and the floor structure. The design required that the outer piled support be separated from an inner shotcrete wall by a two component waterproofing system consisting of a drainage layer and a bentonite mat. The inner shotcrete wall was not designed to be waterproof or subject to external hydrostatic loading, due to the presence of the drainage layer. Nelson Studs

welded to the "I" beams in the pile wall supported the inner shotcrete wall from the piled wall.

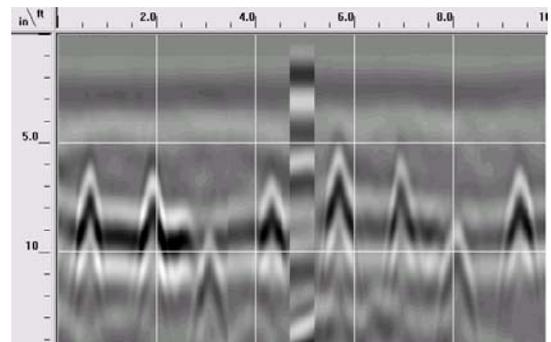
A detailed review of the project history was followed by several site visits to: (1) conduct a radar survey and profile of the walls, (2) observe and document the results of an extensive wall coring program, (3) meet with the Project Team, and (4) orient one of two specialist, chemical grouting companies that could become involved with waterproofing the West and North Walls

Characterization of the as built wall and floor conditions buttressed opinions regarding the probable cause(s) of waterproofing failure and methods required for repair.
