BULLETIN

News from *SubTerra, Inc.*[®]

Longview Boulder Blast Snohomish County, Washington

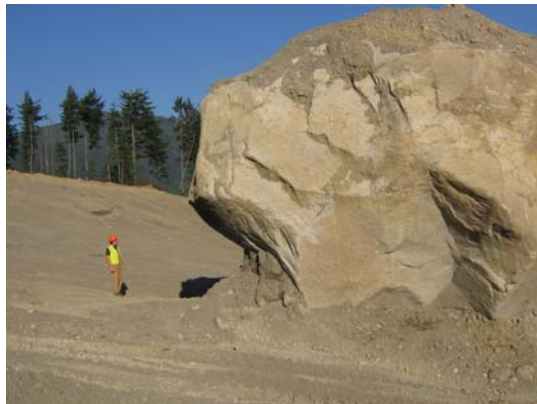
This photograph shows the "glacial erratic" perched high on the gravel mine high-wall. BIC Jerry Wallace is standing to the left of the boulder.

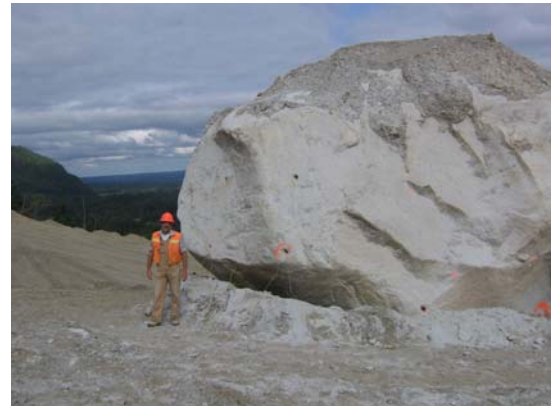
The boulder was successfully split into pieces that could be handled by the on site equipment without any fly rock.
