# BULLETIN

## **US Army Corps of Engineers Cougar Dam Gate Chamber Rock Support. Blue River, Oregon**

*Cougar Dam's original Diversion Tunnel constructed in the mid 1950s was plugged and abandoned after construction of the dam was completed. As part of the Willamette Temperature Control Project, the diversion tunnel was rehabilitated in the late 1990s and now, 10 years later, exposed rock in the Gate Chamber had degraded to the point of needing repairs. The contract to perform Gate Chamber Repairs was awarded to Natt McDougall Co. by the US Army Corps of Engineers.*

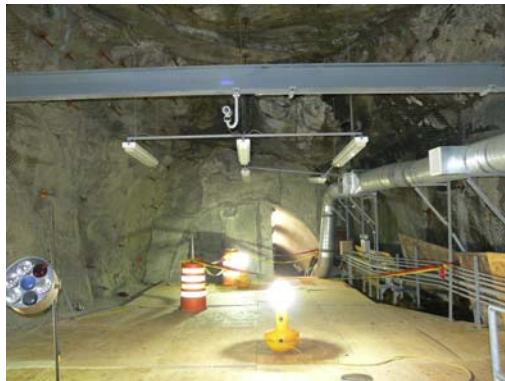
**Left:** Downstream end of the Gate Chamber prior to scaling loose rock.

When the Gate Chamber was constructed, 10- and 20-foot rock anchors were installed to support the excavation with a layer of mesh fastened to the surface to catch any spalling rock. Prior to repairs, there was an estimated 10 CY of loose rock behind the mesh with about 4 CY in a

single overhead pocket. This pocket was full of intact pieces weighing in excess of 300 lbs each. The loose rock was released in a controlled manner and the mesh was reattached with 4-foot split set anchors.

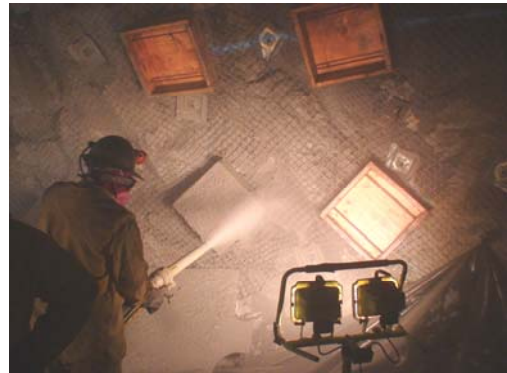
**Top:** Nozzleman certification test panels.

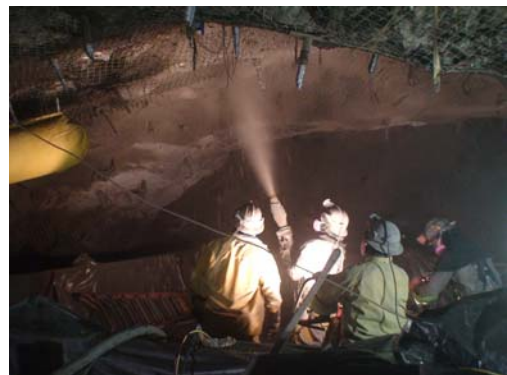
**Above:** Placing shotcrete overhead from scaffolding more than 15 feet from the Gate Chamber floor.

The improved ground support included an initial layer of plain shotcrete followed by a final 4-inch shotcrete layer reinforced with steel fiber and imbedded 6" x 6", W2 x W2 wire mesh.
