Howard Hanson Dam Blasting Near the Concrete Intake Tower and Gate Structures Cumberland, Washington

*As part of the installation of a Cofferdam and Fish Passage Restoration Project, Traylor Brothers, Inc. under the direction of the US Army Corps of Engineers contracted **SubTerra, Inc.** to provide pre-blast and pre-construction inspections and to review and monitor blasting.*

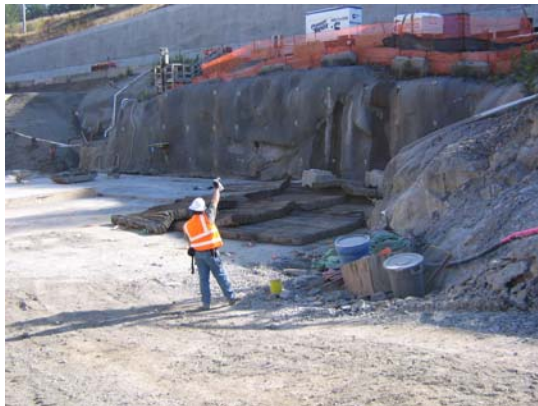
This photograph shows an initial sinking shot located about 100-ft from the intake tower and bridge structure.

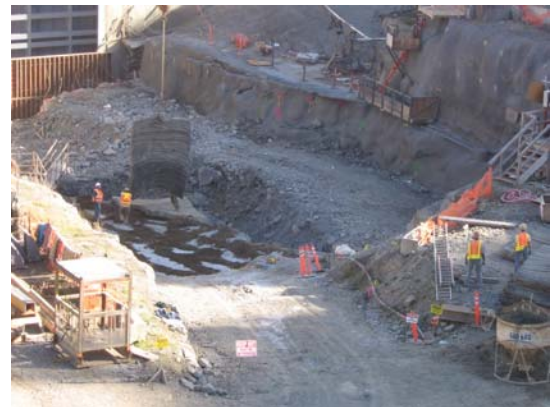
The photograph below shows a sinking shot located approximately 40-ft from the coffer dam. Most shots were designed using a scaled distance of 5 to limit vibrations to below 16 in/sec.

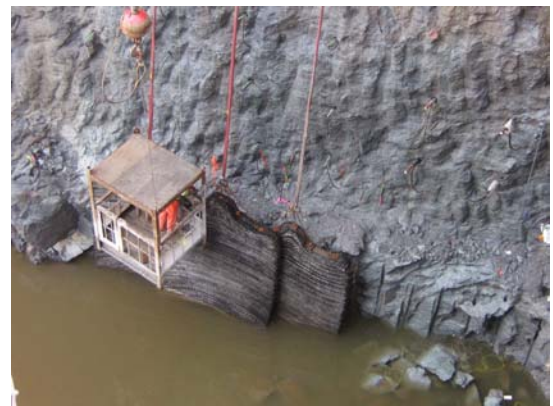
The photograph below shows a sidewall blast that was successfully drilled, loaded, matted, and shot just above the waterline.
